Limited Visual Dam Safety Inspection Summary Report

MA-130

Honokowai – Structure #8

May 2006

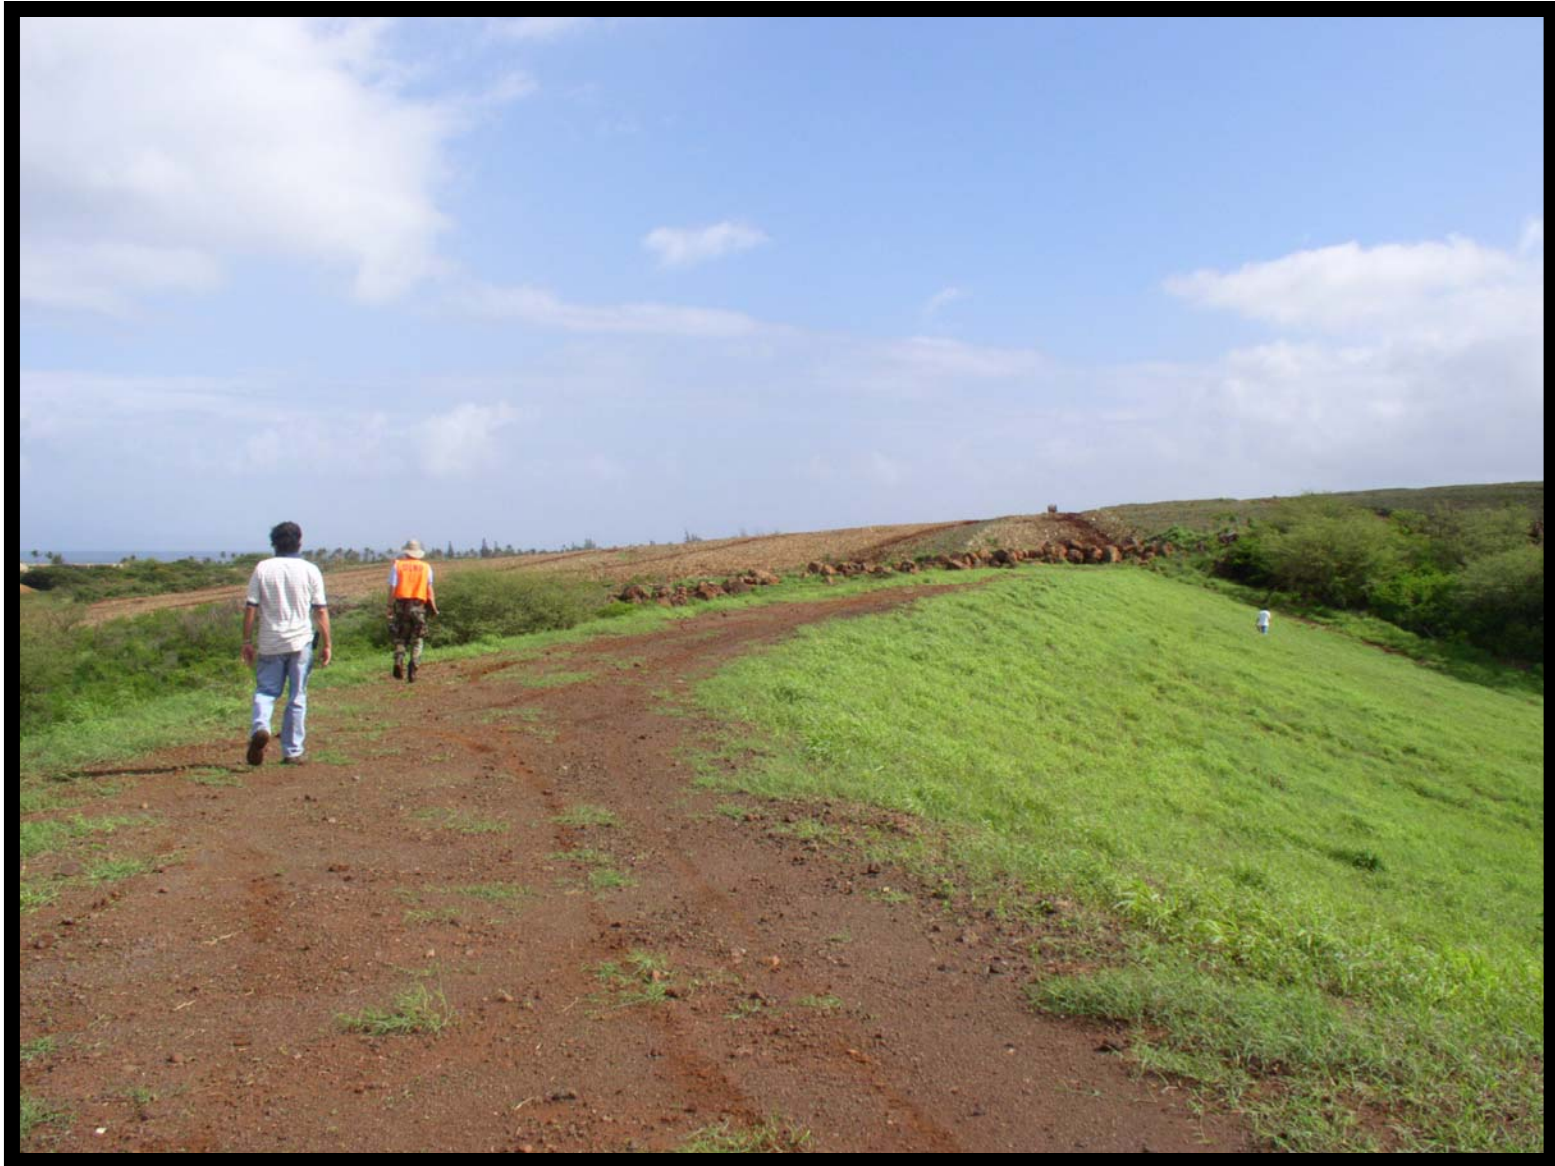
- a. The dam crest appeared to be in satisfactory condition. No corrective actions are required at this time.
- b. Access along the crest was satisfactory.

130 Crest

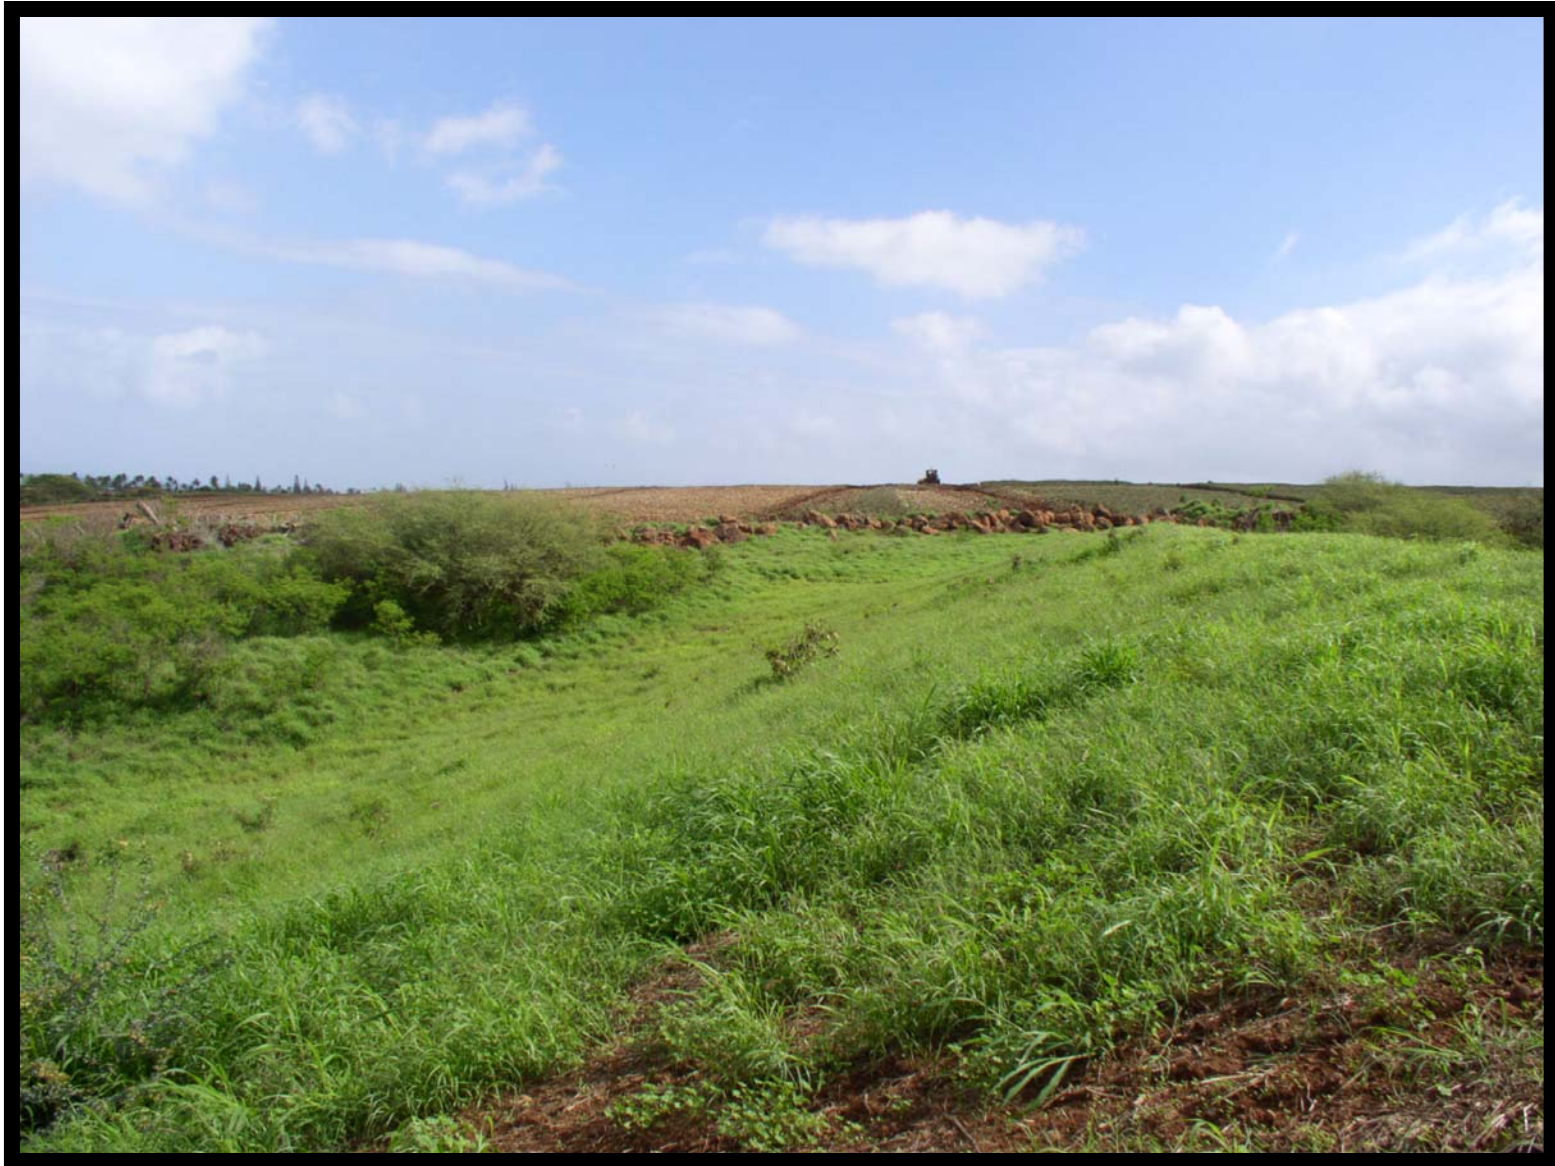
- a. The downstream slope appeared to be in satisfactory condition. No corrective actions are required at this time.

130 Downslope

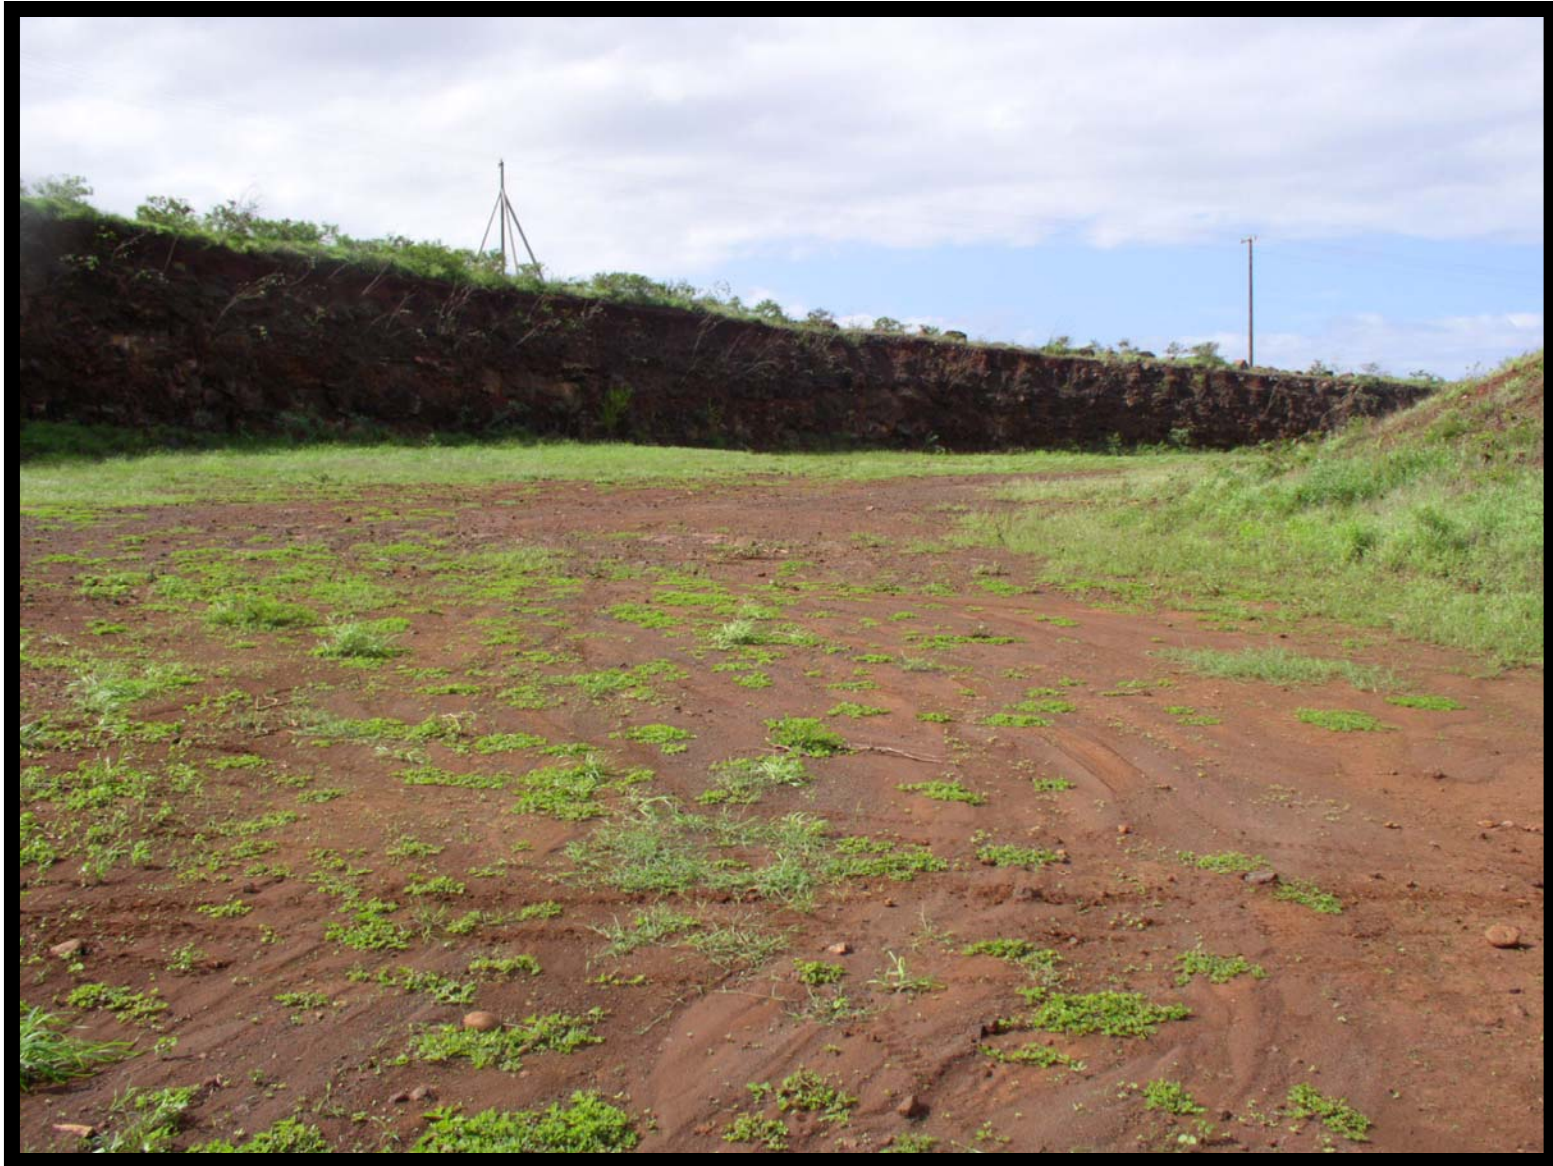
- a. The Spillway appeared to be in satisfactory condition. No corrective actions are required at this time.

130 Emergency spillway

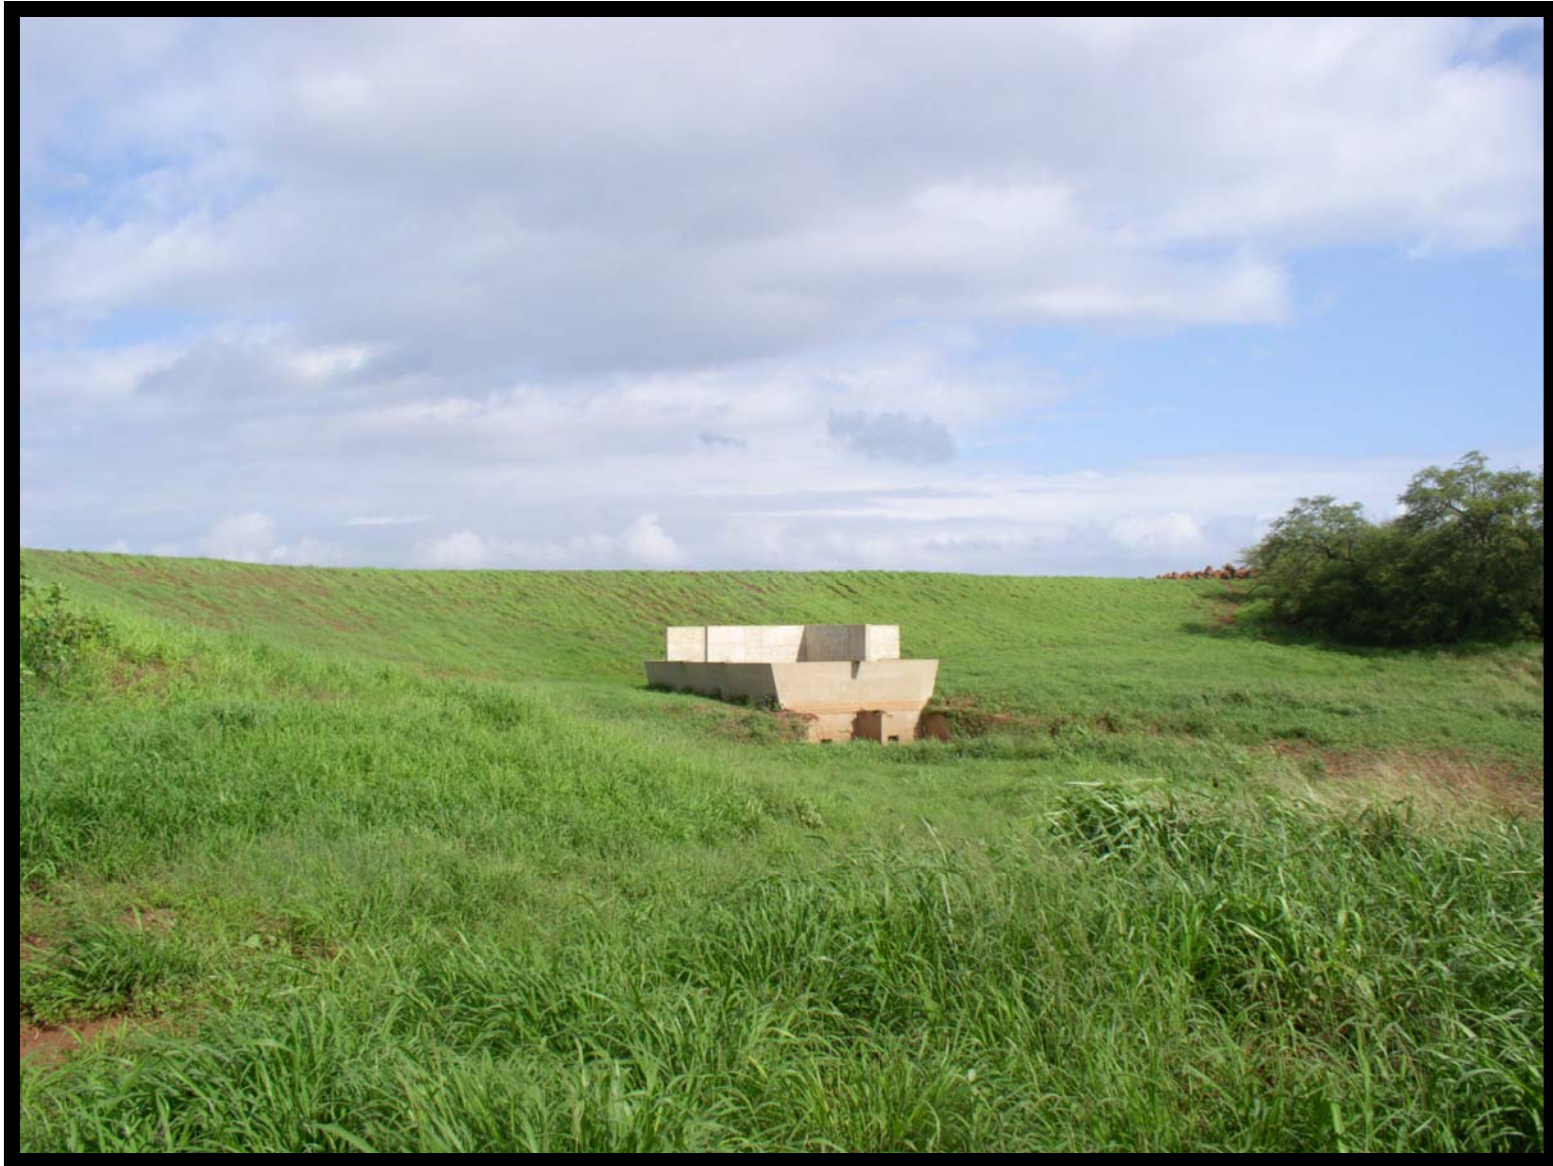
- a. The outlet works appear to be in satisfactory condition. No corrective actions are required at this time.

130 Outflow - outlet structure

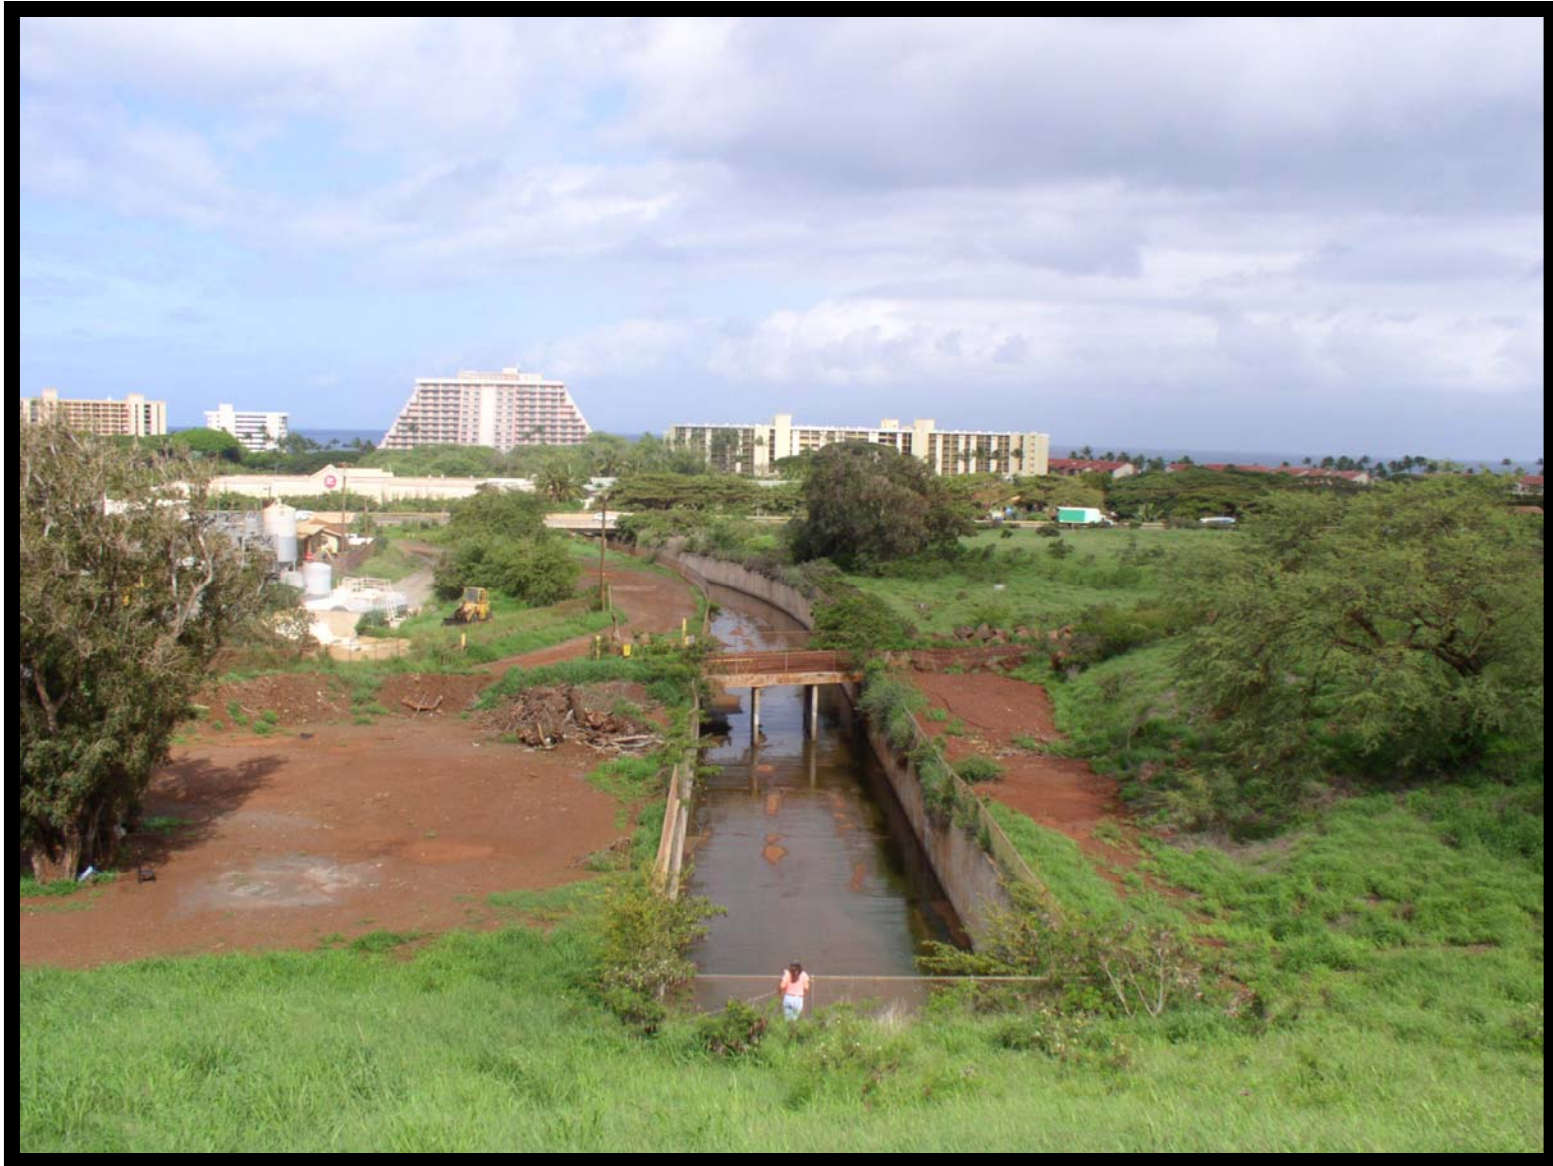
130 Outlet - looking downstream from the crest

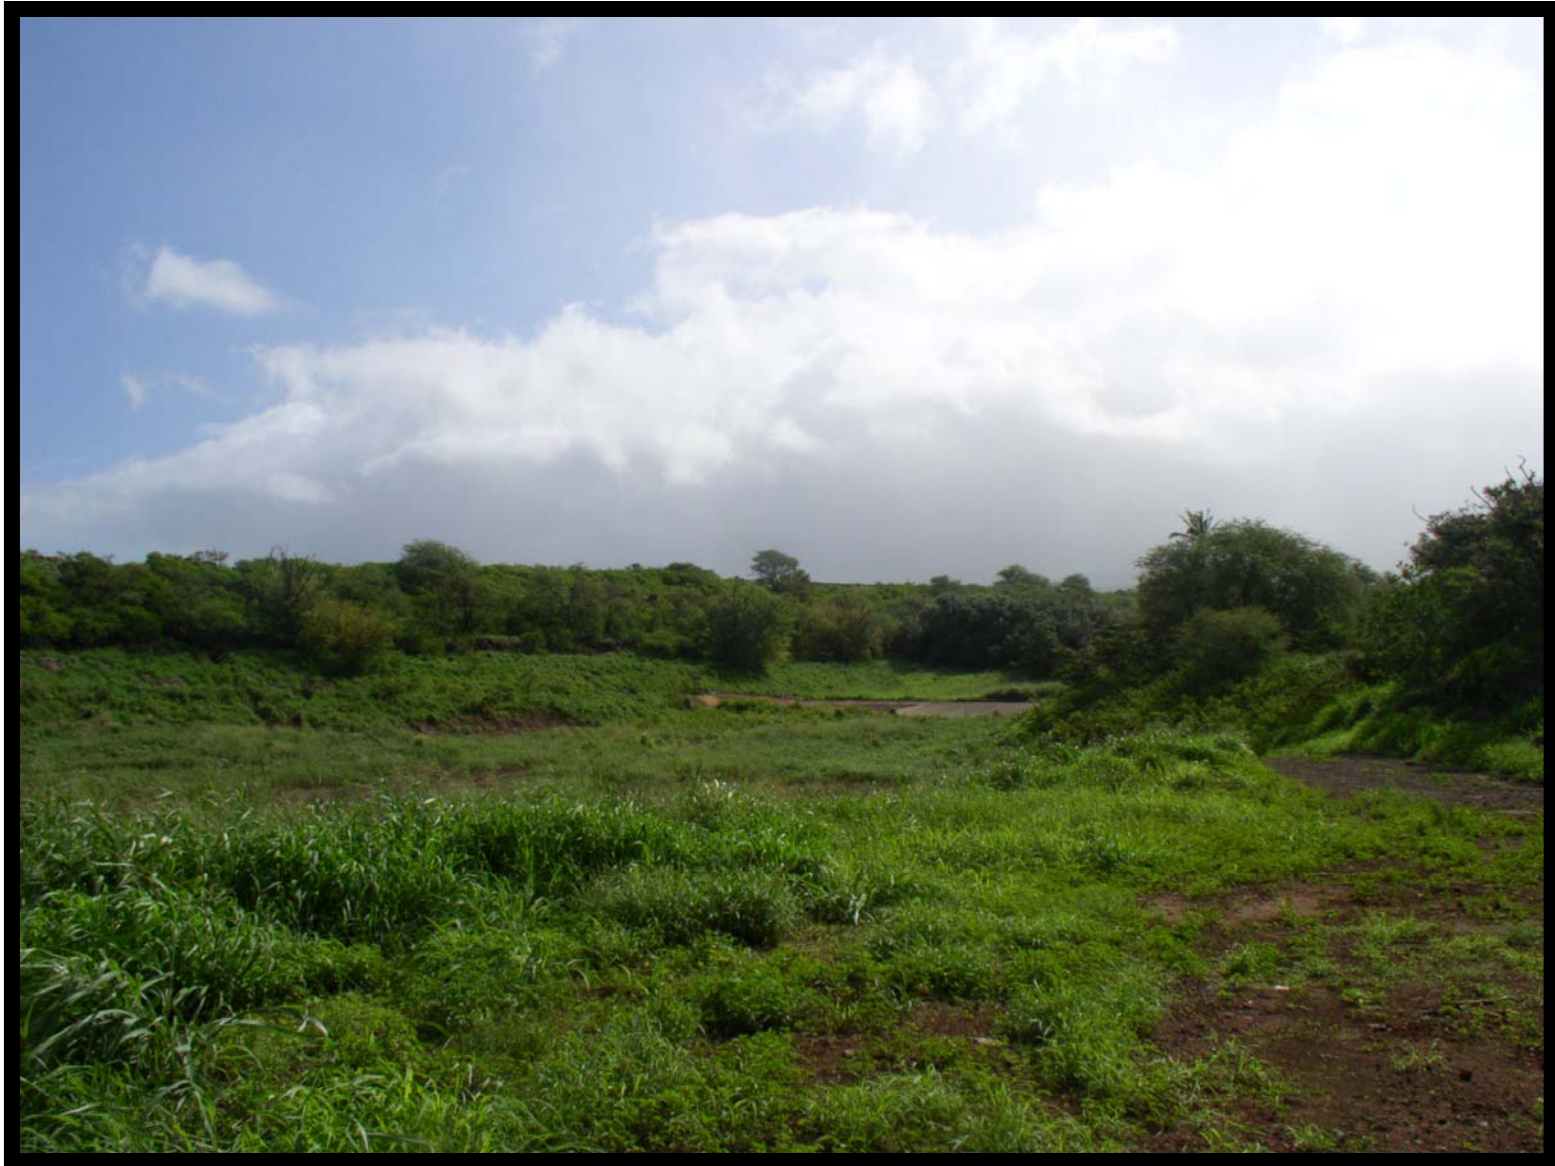
The reservoir was dry at the time of inspection. The normal operating level is estimated to be 0 to 2 feet. No staff gage was observed.

- a. The reservoir appeared to be in fair to poor condition and requires corrective action.
- b. A staff gage was not observed at this reservoir. Provide some method of quantifying the water level within the reservoir.

130 Reservoir - Note the reservoir is dry.

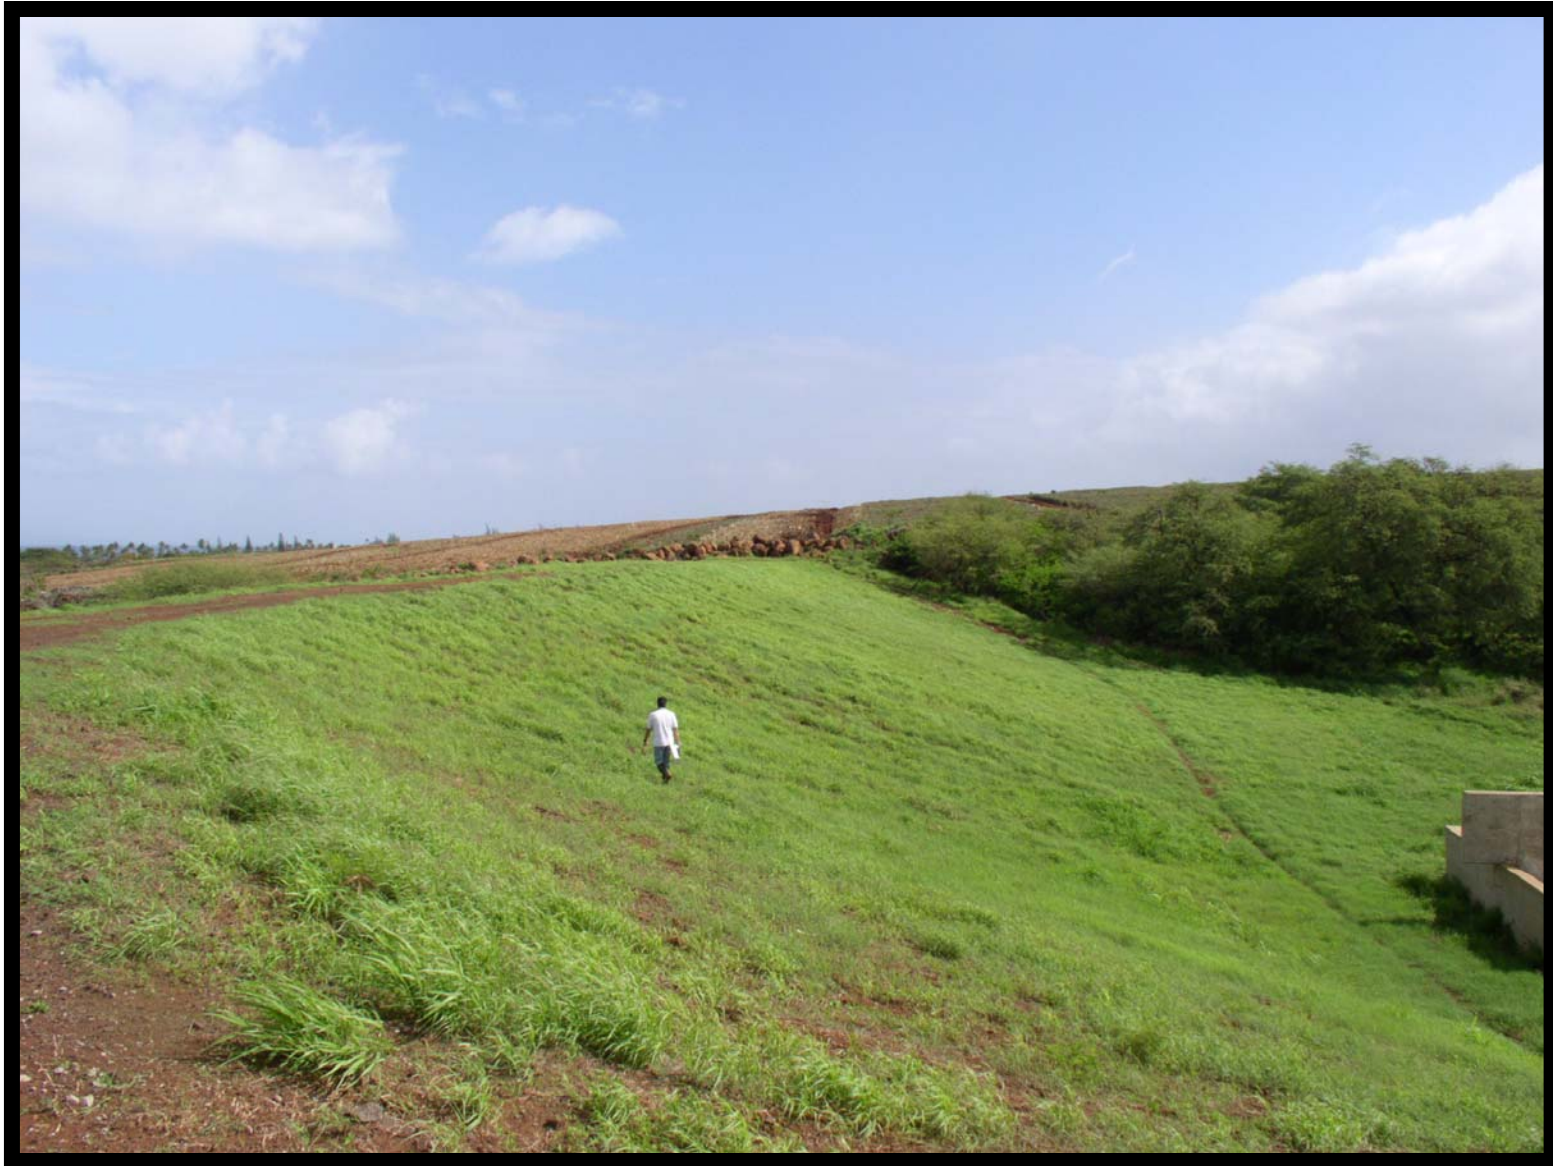
- a. The upstream slope appeared to be in satisfactory condition. No corrective actions are required at this time.

130 Upslope
